EVALUATION OF KAISER MX19-B AND MX19-C  
ALUMINUM HONEYCOMB LANDING MAT

Army Engineer Waterways Experiment Station  
Vicksburg, Mississippi

MISCELLANEOUS PAPER S-73 II

March 1973

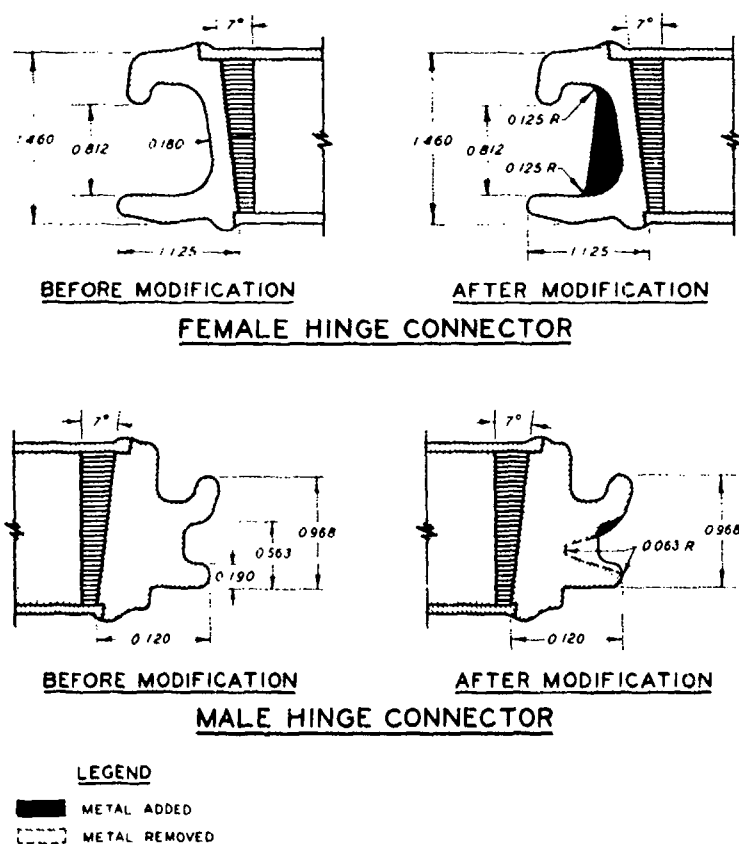
Fig. 2. Modification of MX19 male and female connectors

10. Since previous EDT's of MX19 mat had established a fairly consistent failure mode along the female connector,<sup>1,2</sup> modifications of the male and female connectors, directed towards extending the service life of the mat, were incorporated in the design (see fig. 2). The MX19-B had the following modifications:

- a. The female connector was strengthened by increasing the thickness of the vertical member to reduce flexure and deflection.
- b. A wedge of metal was removed from between the lip and flange of the male connector (fig. 2) to relieve the concentrated stresses between the male and female connectors at the load transfer point.
